One Career Fire Fighter/Paramedic Dies and a Part-time Fire Fighter/Paramedic is Injured When Caught in a Residential Structure Flashover – Illinois

Revised on September 30, 2010. Revised on November 17, 2010.

Report #F2010-10

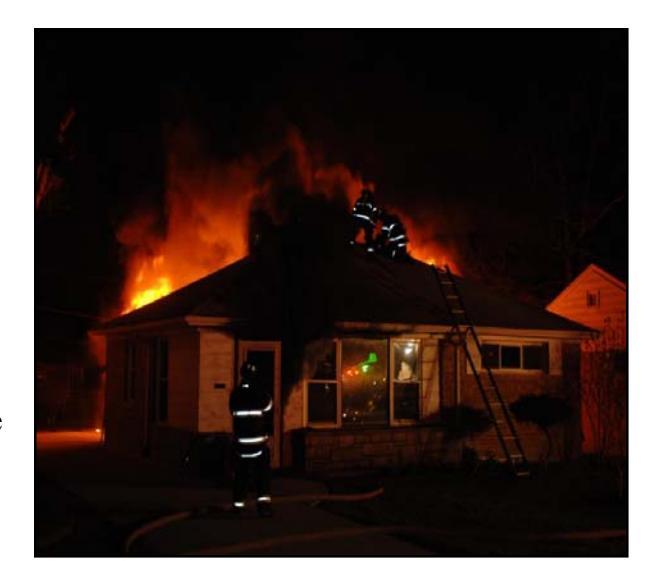
Scene conditions after crews advanced inside. (Photo courtesy of Warren Skalski.)

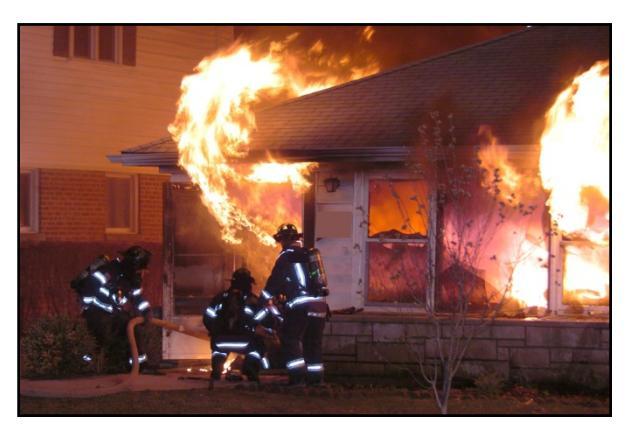
View of flashover. (Photo courtesy of Warren Skalski.)

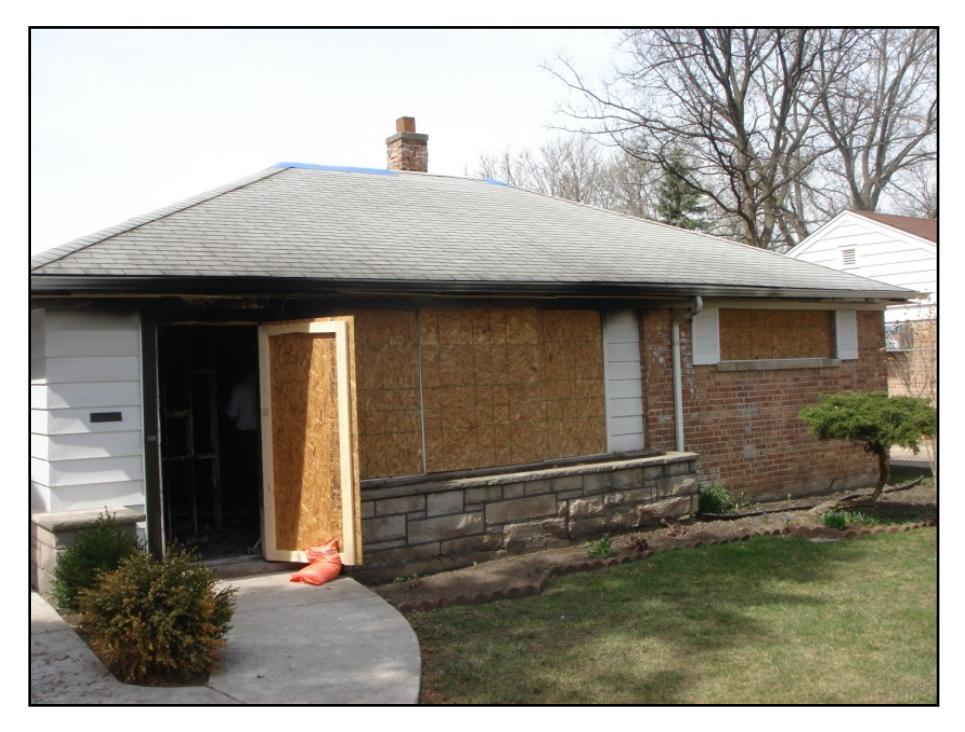
Built in 1951, this single family one-story house of Type V wood frame construction contained approximately 950 square feet of living space (see Photo 1 and Diagram 2). A two-car garage of Type V wood frame construction was located at the rear of the house and was connected to the house by an addition (family room) which was added at some point. The house was built on a concrete slab and contained a small attic space. Traditional drywall over interior wood framing was complemented with a brick veneer exterior. Since the house was built it had undergone permitted changes that included a concrete driveway, new windows, and a new asphalt shingled roof. According to the local building official, the addition (see Photo 2) between the garage and house provided additional living space (Type V wood frame construction). There was no recorded permit for this addition.

Photo 1. View from A-side of house. (NIOSH photo.)

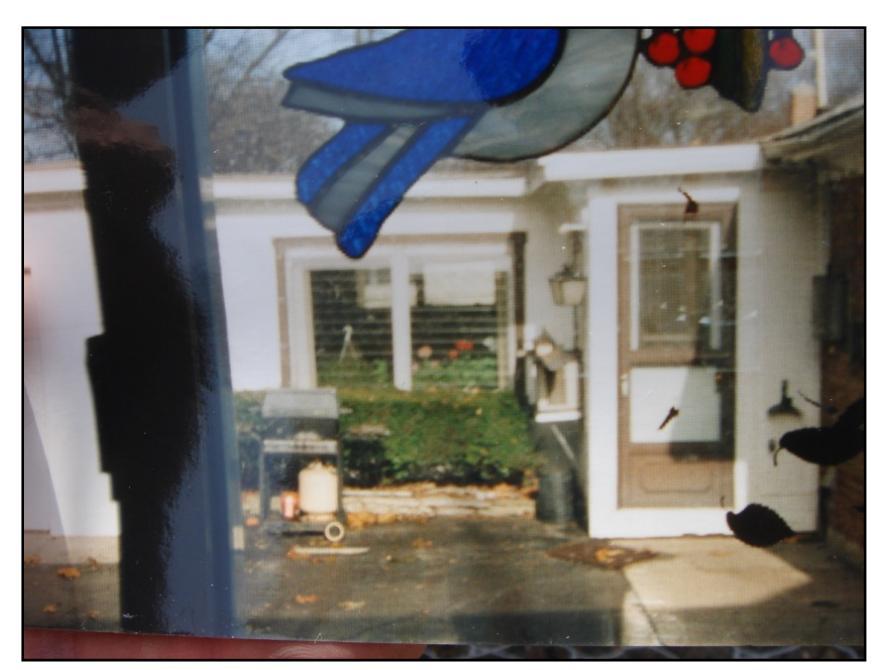
Photo 2. Looking from the B-side, photo taken by neighbor of C-side addition prior to fire. (Photo courtesy of neighbor.)

The fire is believed to have originated within the addition, but a cause has not been determined. NIOSH investigators reviewed written witness statements taken from the civilian and the audio 911 call she placed. She was beckoned by her husband when the chair he was sitting in was believed to be on fire. She stated she observed black smoke and flames coming from underneath the chair and she immediately attempted to put the fire out and call 911. Her efforts were unsuccessful. She managed to escape from the house, but her husband perished within the fire. Fuel sources for the fire included polyurethane foam padding, upholstered furniture, a motor vehicle within the garage, and other combustible materials. Also, the civilian victim had three medical oxygen bottles [one D-cylinder (425 liters)] within the addition for his personal use. It is not known if the oxygen within these bottles contributed to the growth and behavior of the fire.

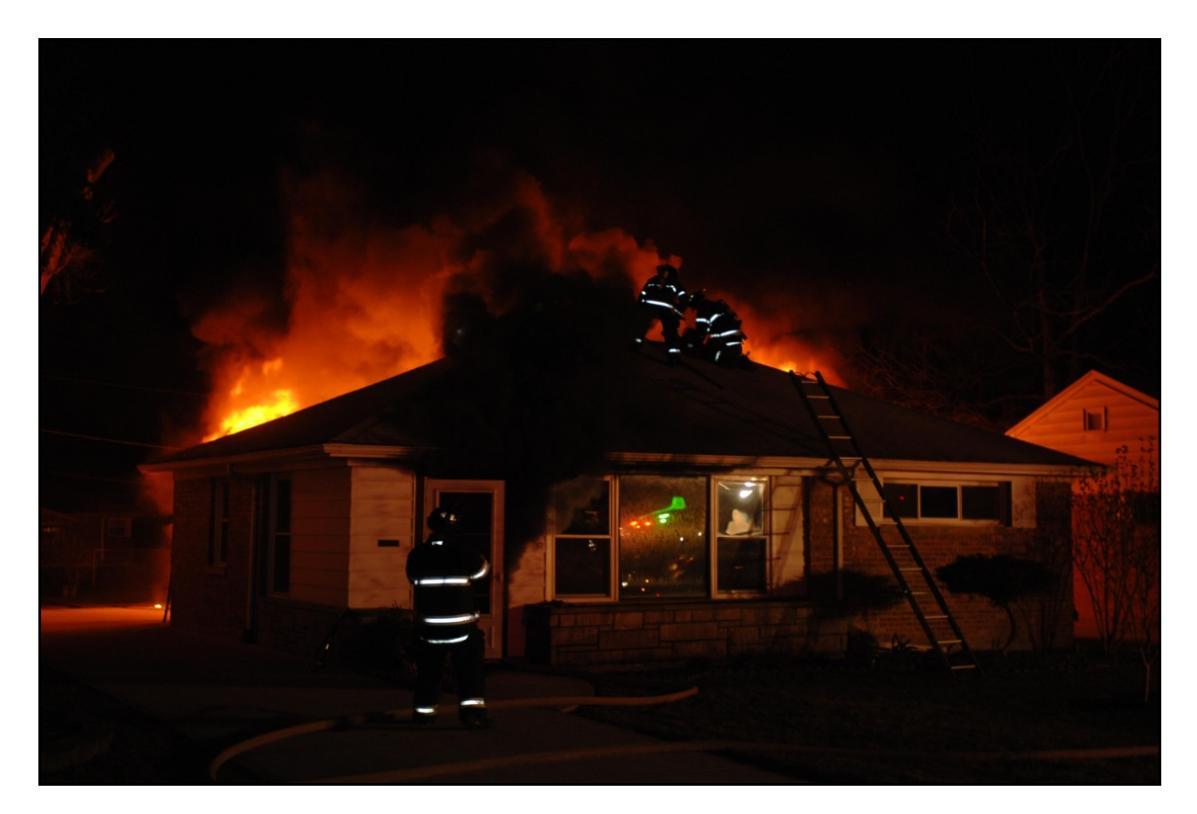
Photo 3. Looking toward the A/B corner, the victim, FF1, and injured fire fighter/paramedic are operating the 2 <sup>1</sup>/<sub>2</sub> inch hoseline inside the structure, and FF2 and FF3 are searching the house. Crews are preparing to ventilate the roof. Large volume of fire and smoke noted at rear of home, C-side. Thick, black smoke can be scene billowing out the front door, A-side. A-side picture windows are covered in soot.

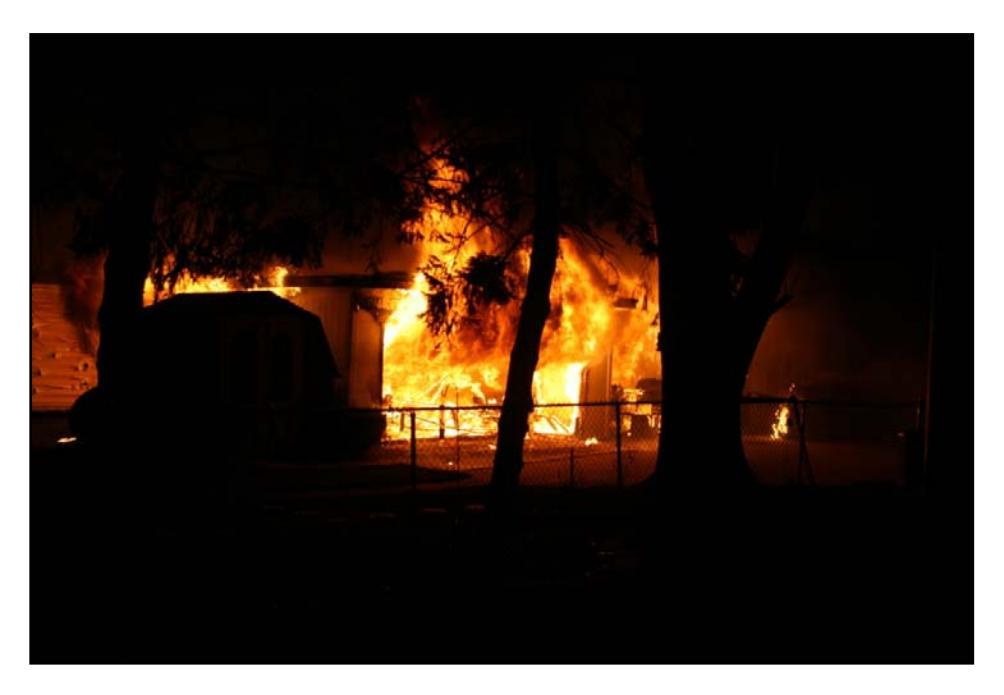
Photo 4. Volume of fire noted at C-side that IC would have seen during his size-up. (Photo courtesy of John Ratko.)

Recommendation #1: Fire departments should ensure that a complete 360 degree situational size-up is conducted on dwelling fires and others where it is physically possible and ensure that a risk-versus-gain analysis and a survivability profile for trapped occupants is conducted prior to committing to interior fire fighting operations.

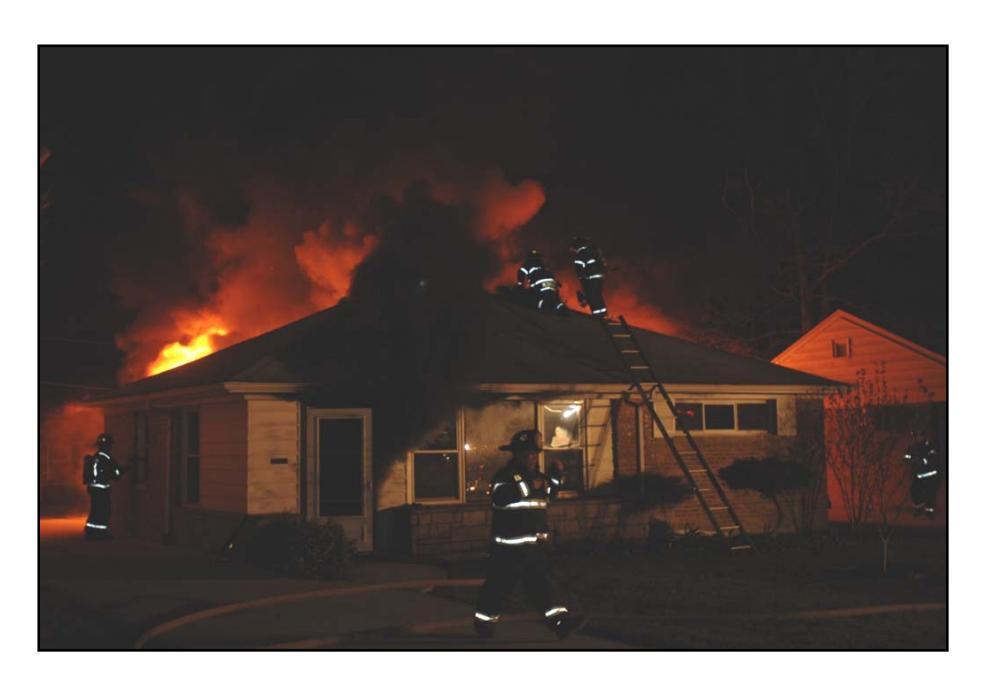
Photo 5. Looking toward the A/B corner, a fire fighter on B-side of the house is preparing to vent the kitchen window. Fire fighters are preparing to protect D-side exposures and ventilate. Crews are still operating inside and on the roof. (Photo courtesy of Warren Skalski.)

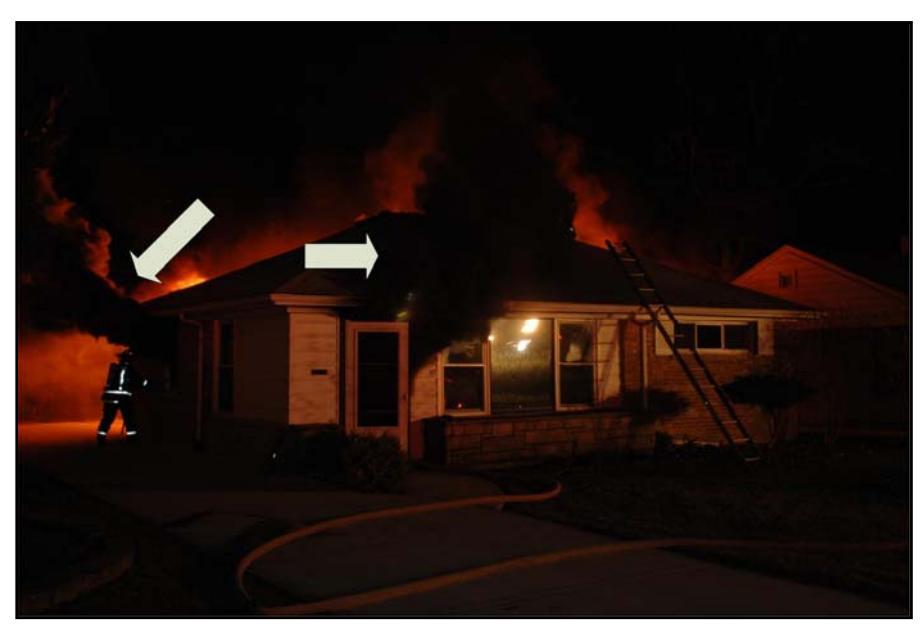
Photo 6. Looking toward the A/B corner, the fire fighter has vented the B-side kitchen window. Note the horizontal flow of thick, black smoke from window. This is characteristic of being under extreme pressure. Smoke continues to billow from the front door. Crews are still operating inside and on the roof.

#### Recommendation #5: Fire departments should ensure that incident commanders and fire fighters understand the influence of ventilation on fire behavior and effectively coordinate ventilation with suppression techniques to release smoke and heat.

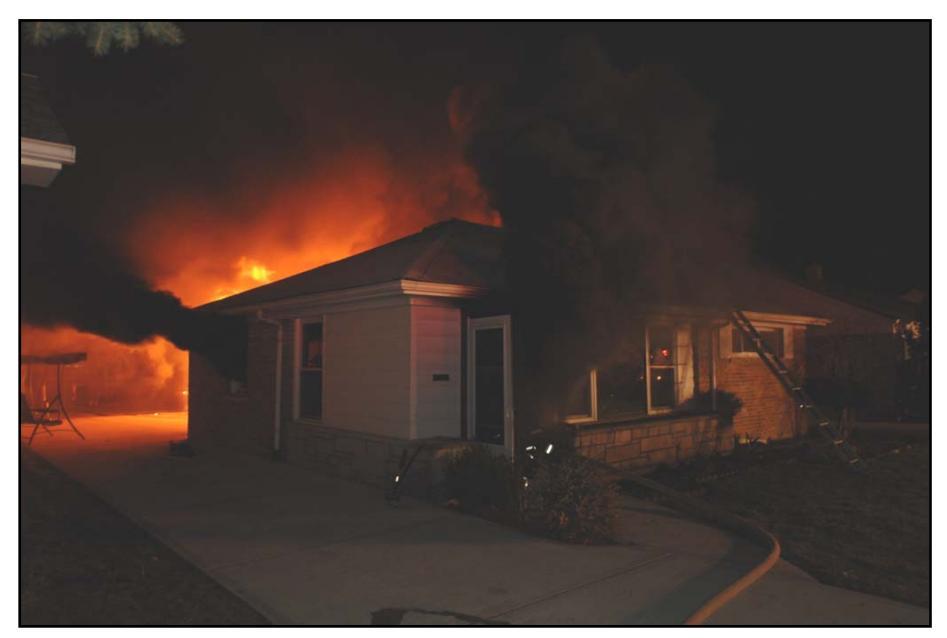
Photo 7. Looking toward the A/B corner, thick, black smoke continues to push out the B-side window that was vented. The volume of smoke venting from the front door has increased, so has fire on C-side. FF1 can be seen in front doorway. Crews are still operating inside and on the roof. (Photo courtesy of Warren Skalski.)

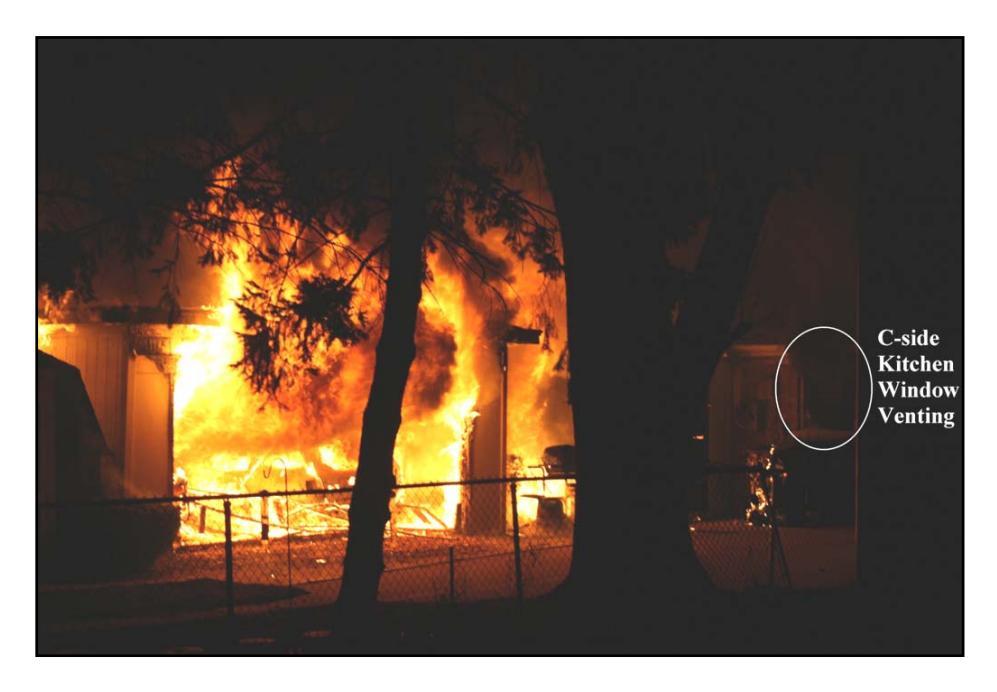
Photo 8. C-side kitchen window is venting. Unknown if this window failed or was manually vented. (Photo courtesy of John Ratko.)

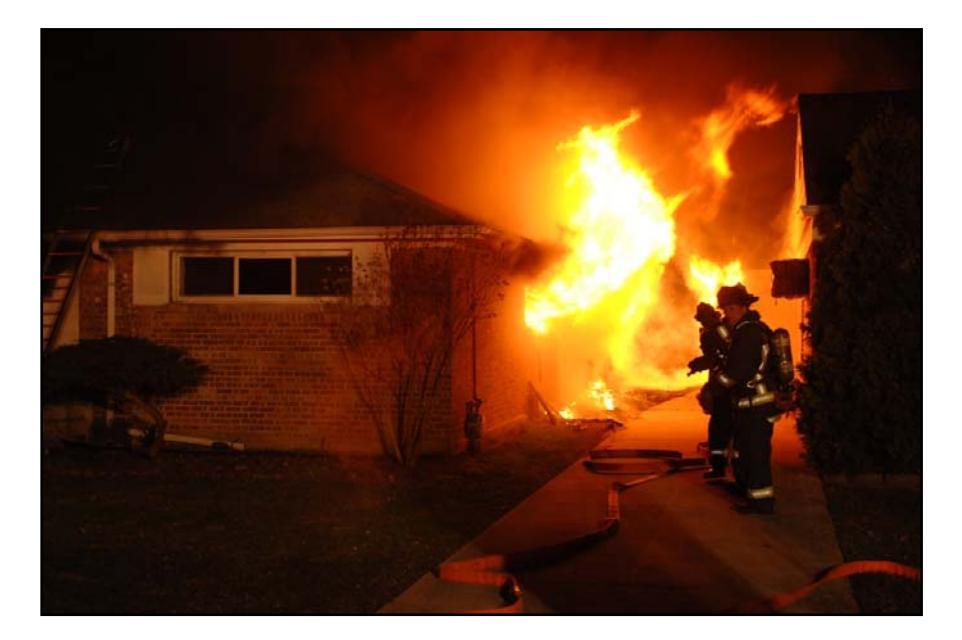
Photo 9. Looking toward the A/D corner, flashover has occurred and fire can be seen blowing out the D-side window that was vented. (Photo courtesy of Warren Skalski.)

During this incident, uncoordinated ventilation occurred while the hoseline and search and rescue crews were inside the house. The victim and other fire fighters, within the small house, were between the fire and the ventilation source. One fire fighter accounts heavy, turbulent, black smoke pushing from a window on the B-side after it was broken. Shortly after, the house sustained an apparent ventilation-induced flashover.

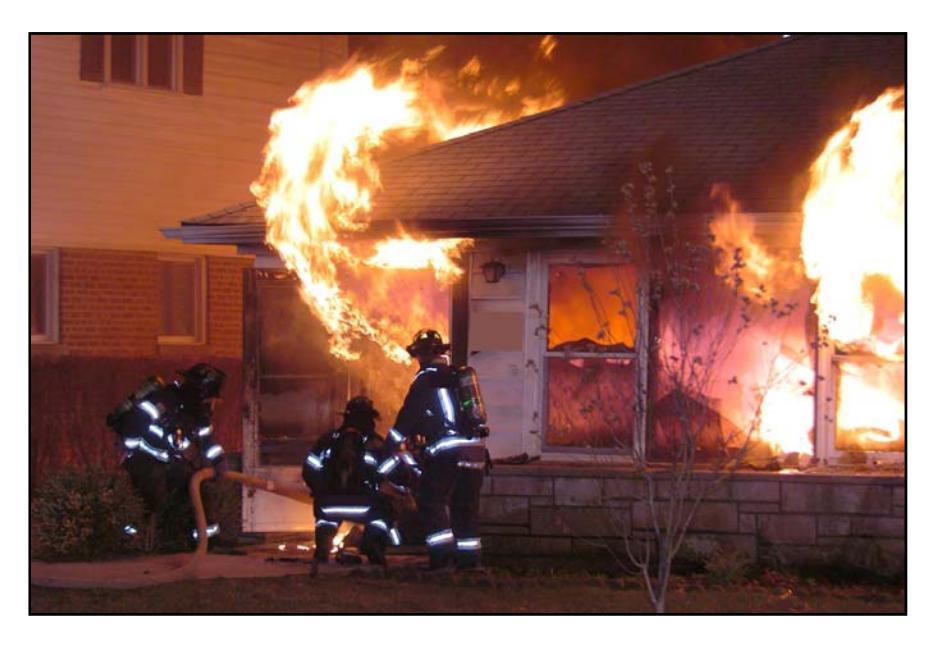
Photo 10. Looking toward the A-side front door, the flashover has just occurred. FF1 is pulling on the 2<sup>1</sup>/<sub>2</sub>-inch hoseline and FF2 and FF3 are attempting to pull the injured fire fighter/paramedic from the house. She is just inside the door way and the downed fire fighter (victim) is still in the house.

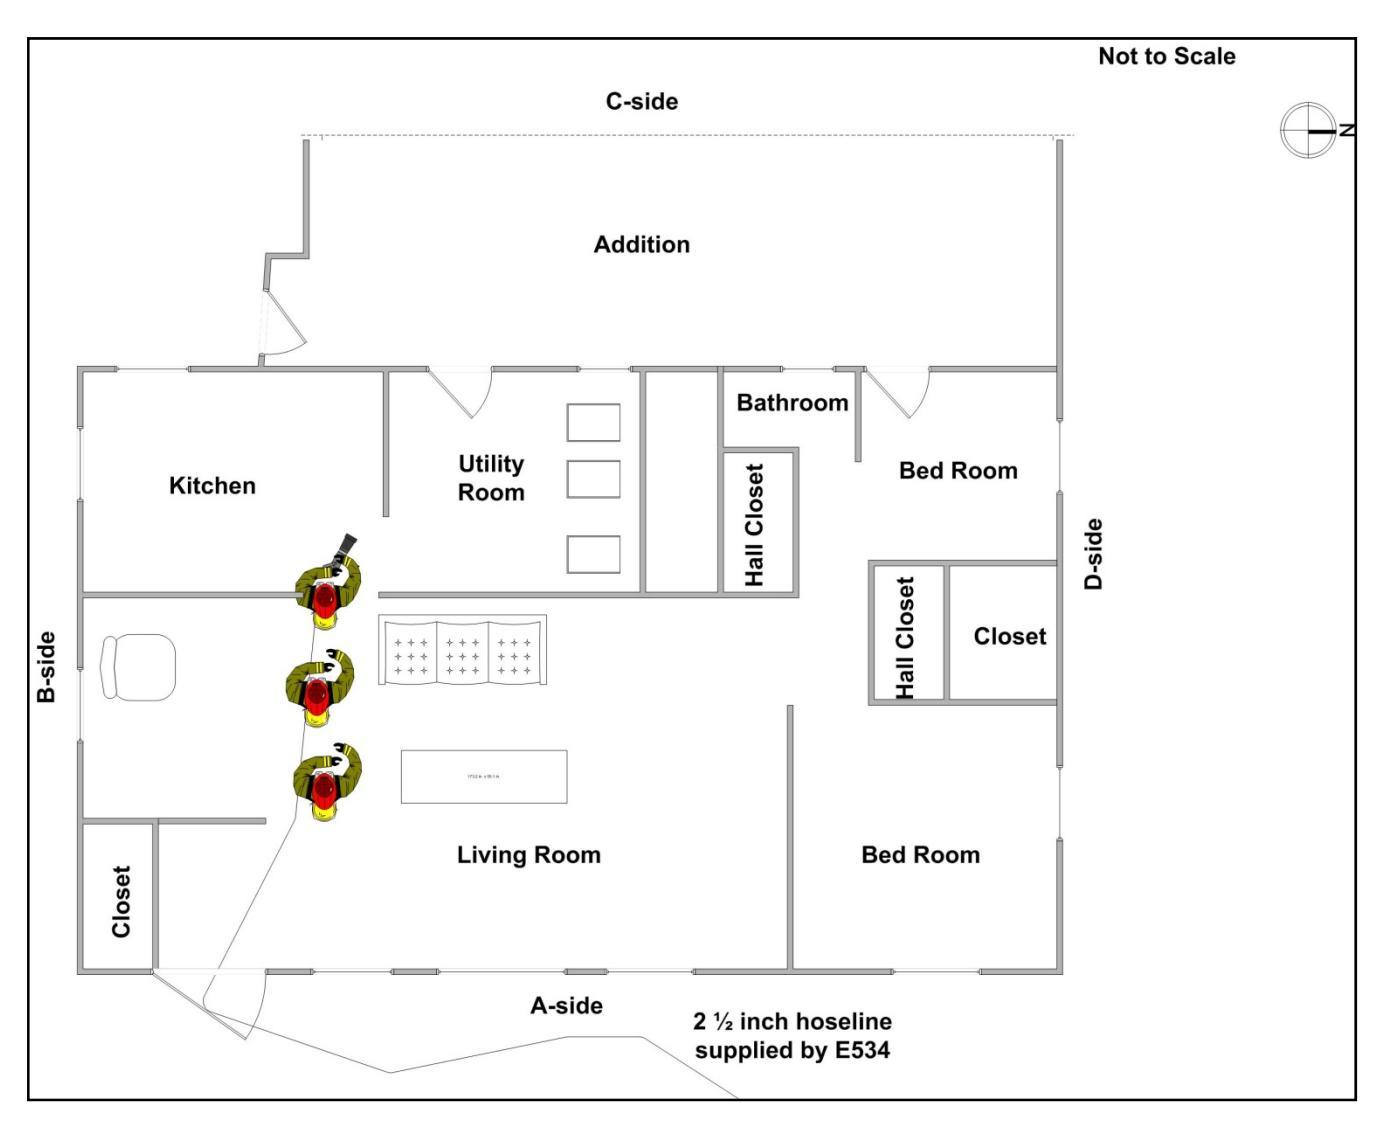
Diagram 3. FF1, victim, and injured fire fighter/paramedic made entry into house stopping at the doorway between the kitchen and utility room, approximately 12 feet from the front door.

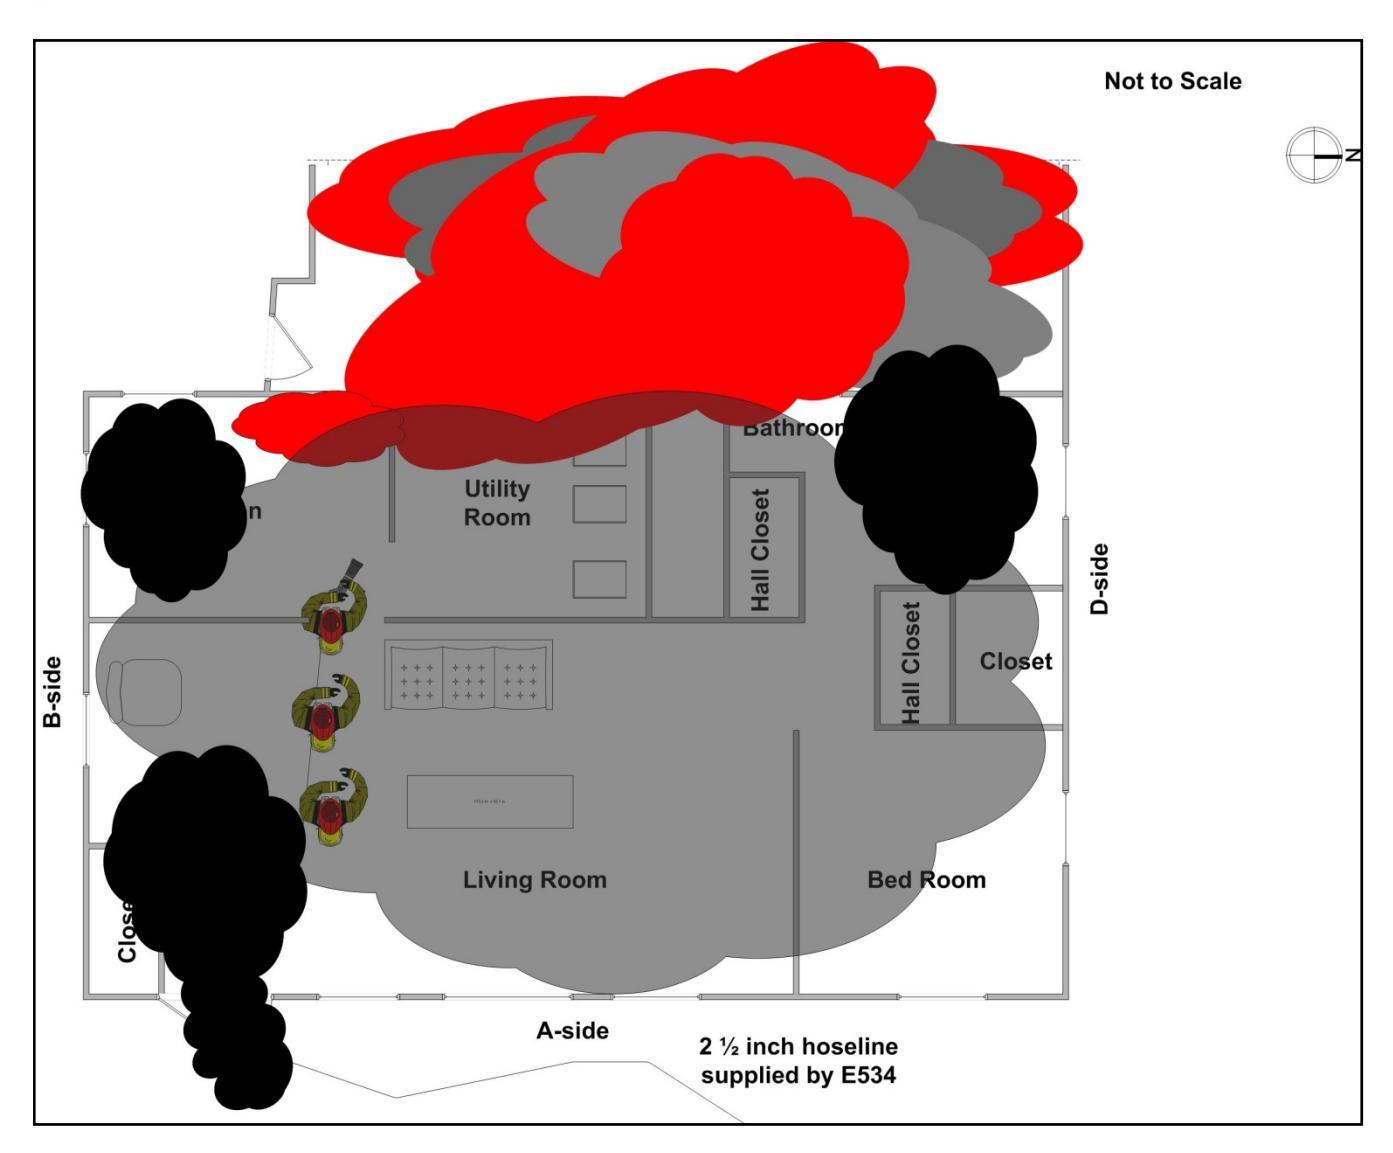
Diagram 4. Fire fighters recall the smoke being very thick and black while operating within the house. In the diagram, the smoke around the fire fighters was made transparent to convey their location. FF2 and FF3 are not included within this diagram.

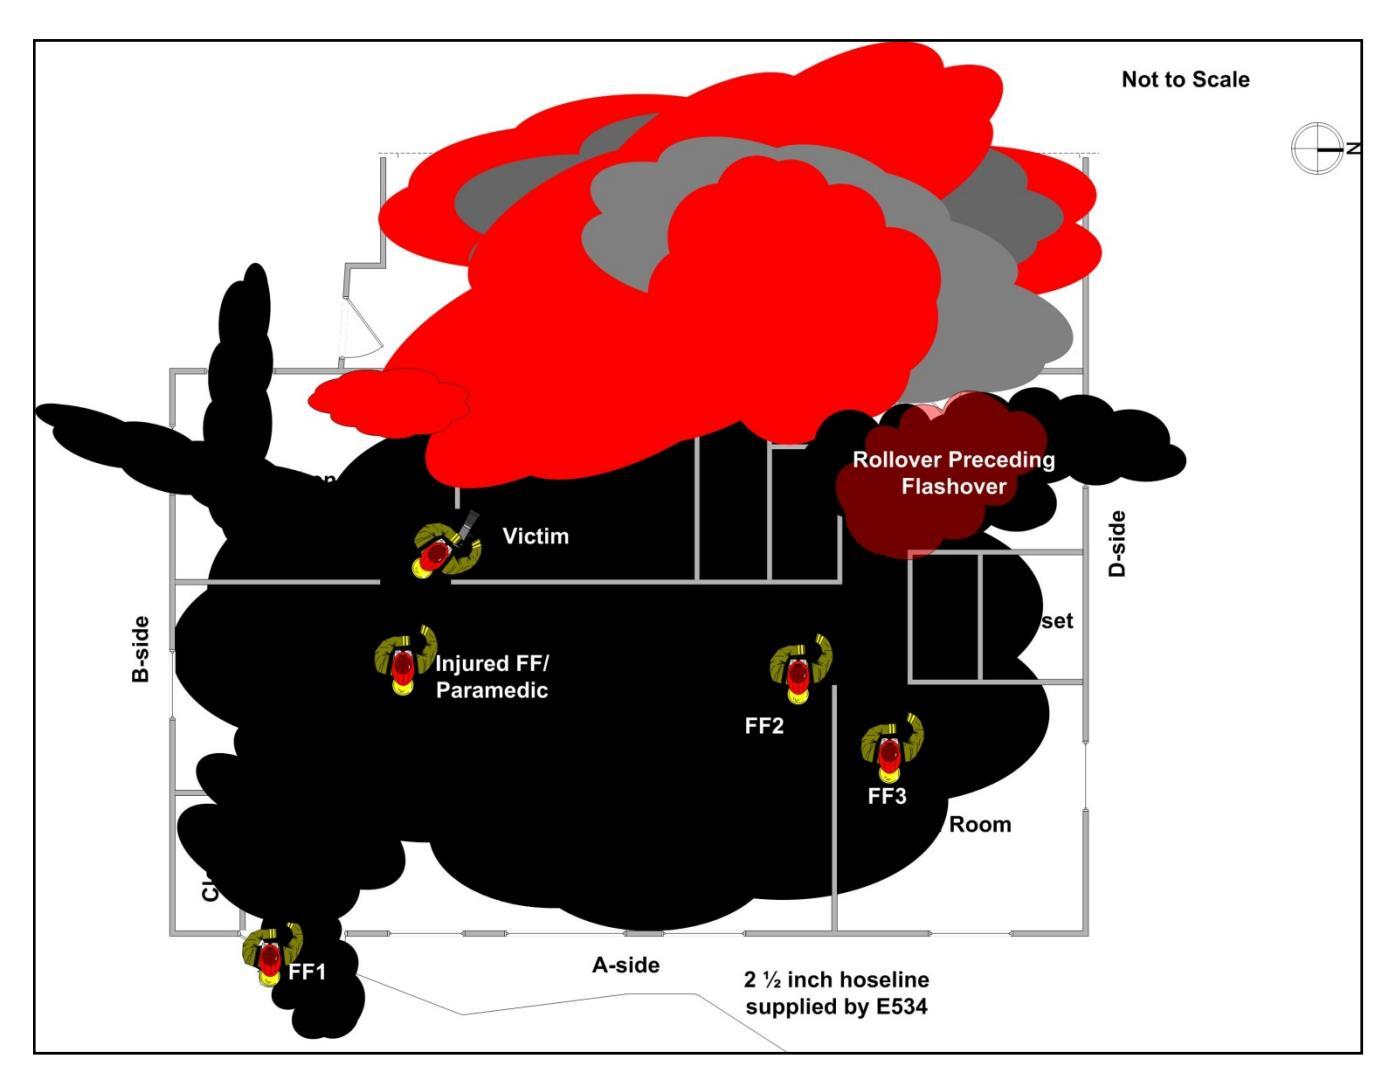
Diagram 5. Conditions within structure preceding the flashover. Windows vented on B-, C-, and D-sides.
